General Summary

Aussie Home Inspections

Inspection Report

Date: 1/17/2009	Time: 8:55 AM	Report ID: Holten
Property:	Customer: SAMPLE	Real Estate Professional: Shirley Jonas Ridge Reality

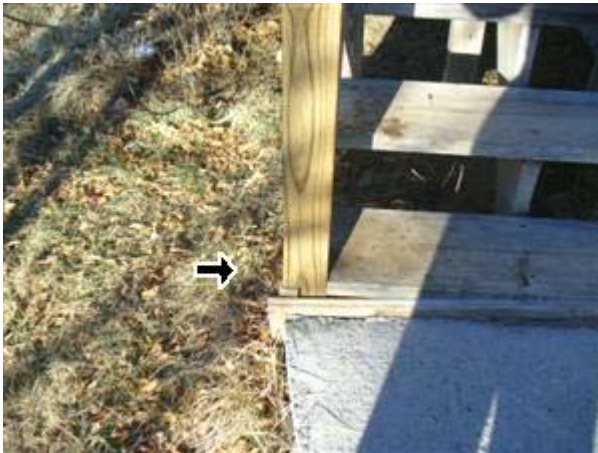
2.3 Picture 1

Corner post at the bottom of the back stairs is loose. This could result in an injury if not corrected. Recommend repair by somebody qualified.

2.3 Corner post at the bottom of the back stairs is loose. This could result in an injury if not corrected. Recommend repair by somebody qualified.

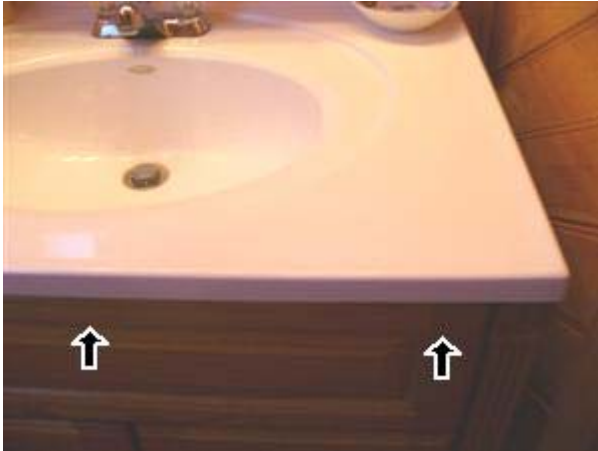
3.4 Picture 1

Both of the wall cabinets in the bathrooms are not secured to the wall at the bottom section. This should be corrected to avoid a possible injury. Sink counter tops are loose in all bathrooms and need to be secured to base cabinets to avoid possible damage to plumbing system. Recommend repair by a qualified person.

3.4 Both of the wall cabinets in the bathrooms are not secured to the wall at the bottom section. This should be corrected to avoid a possible injury.

Sink counter tops are loose in all bathrooms and need to be secured to base cabinets to avoid possible damage to plumbing system. Recommend repair by a qualified person.

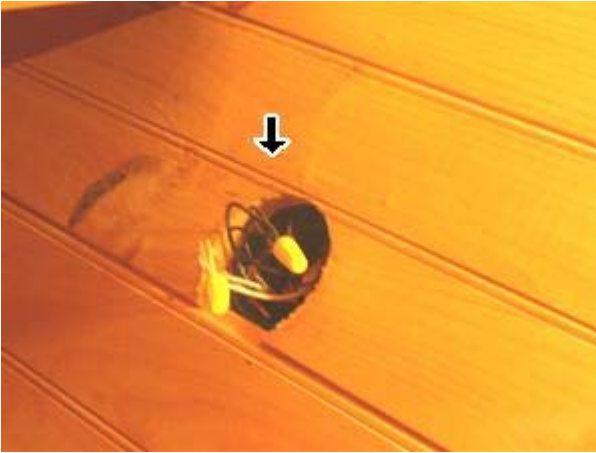
6.3 Picture 1

This junction box in the upstairs bedroom storage closet wall should be sealed off with the proper cover for safety reasons. Any electrical work should be done by somebody licensed.

6.3 This junction box in the upstairs bedroom storage closet wall should be sealed off with the proper cover for safety reasons. Any electrical work should be done by somebody licensed.

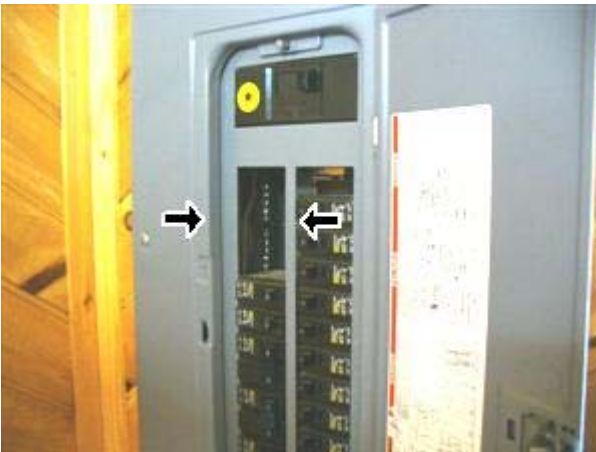
6.6 Picture 1

The main panel box is located in the front entrance room behind the entrance door.

There are breaker cover plates missing in the panel box. This is a safety hazard. A child could possibly put their hand inside the panel. Cover plates should be replaced by a licensed Electrician.

6.6 The main panel box is located in the front entrance room behind the entrance door.

There are breaker cover plates missing in the panel box. This is a safety hazard. A child could possibly put their hand inside the panel. Cover plates should be replaced by a licensed Electrician.

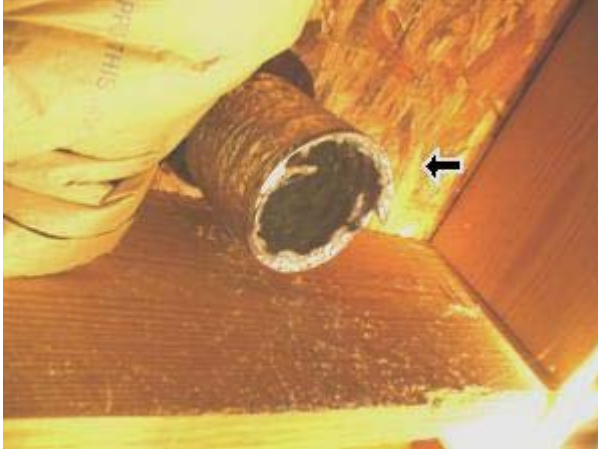
8.4 Picture 1

The dryer is venting to the crawl space. This creates access moisture in the crawl space that can possibly cause damage to the floor system. There is no evidence of damage to the floor system at this time. Recommend vent pipe be vented to the outside of the house by somebody qualified.

8.4 The dryer is venting to the crawl space. This creates access moisture in the crawl space that can possibly cause damage to the floor system. There is no evidence of damage to the floor system at this time. Recommend vent pipe be vented to the outside of the house by somebody qualified.
